Sandy Run Creek Watershed Field Observations and Stormwater Management Improvements

Field Observations

Opportunities for Stormwater Management Improvements

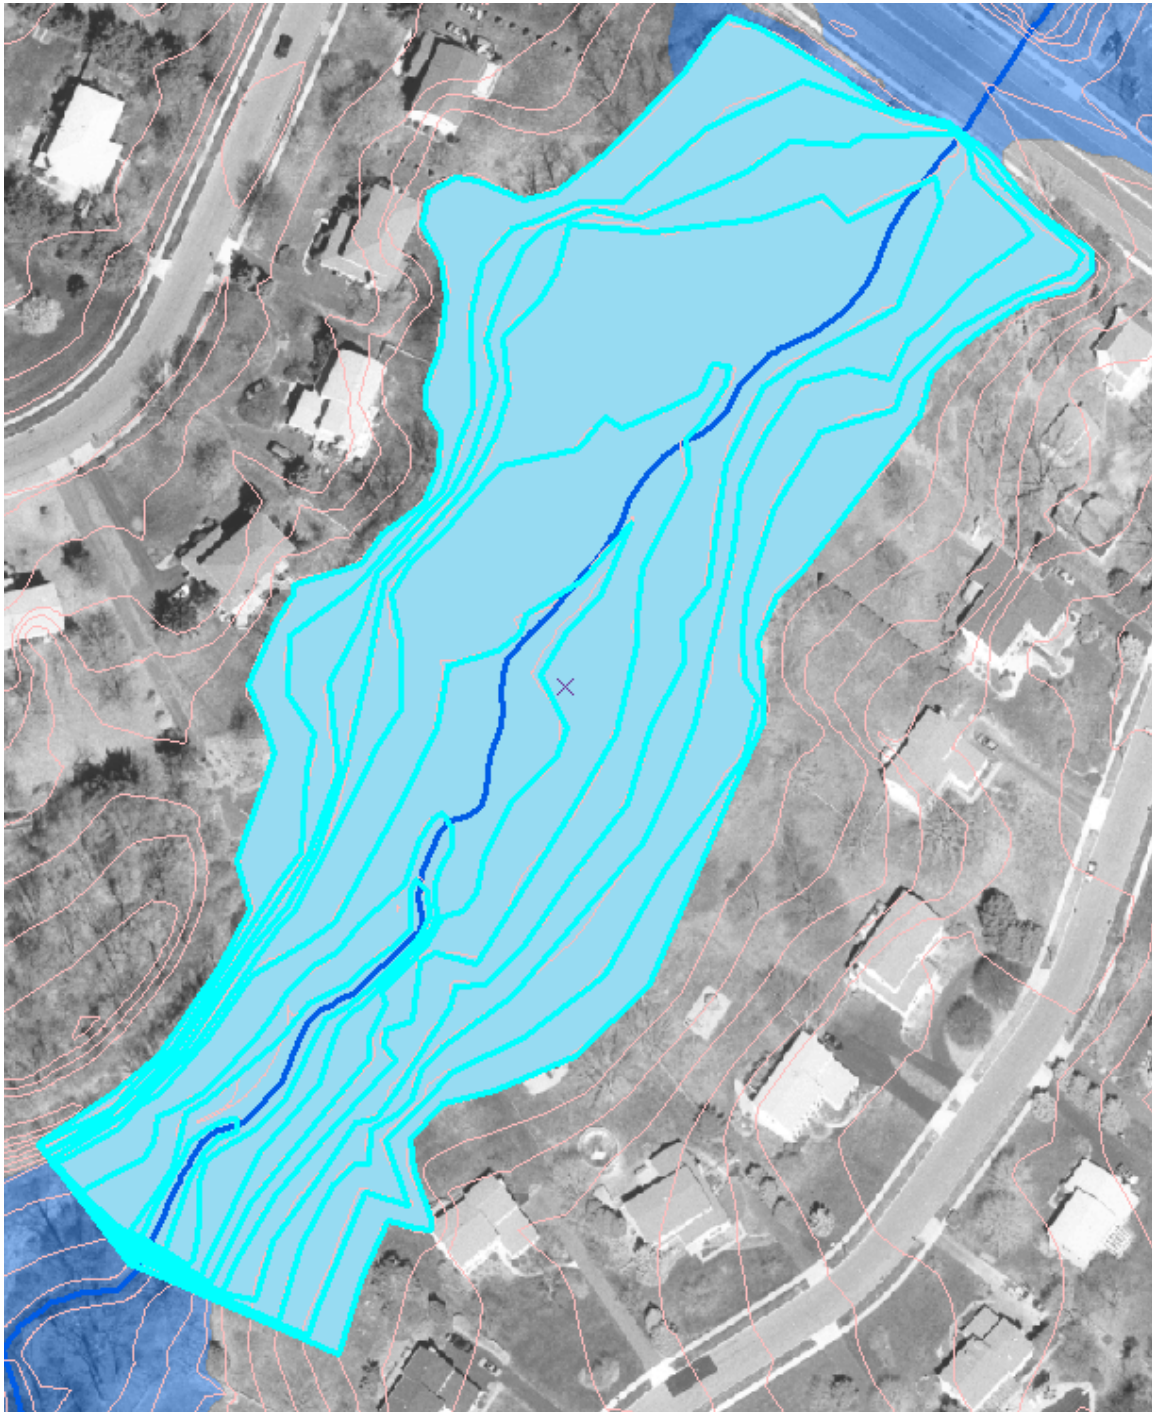
The figure below shows the potential location of retention basin. Location coordinates (2686500 307101). There is a large increase in surface area between the 10 feet to the 12 feet contour.

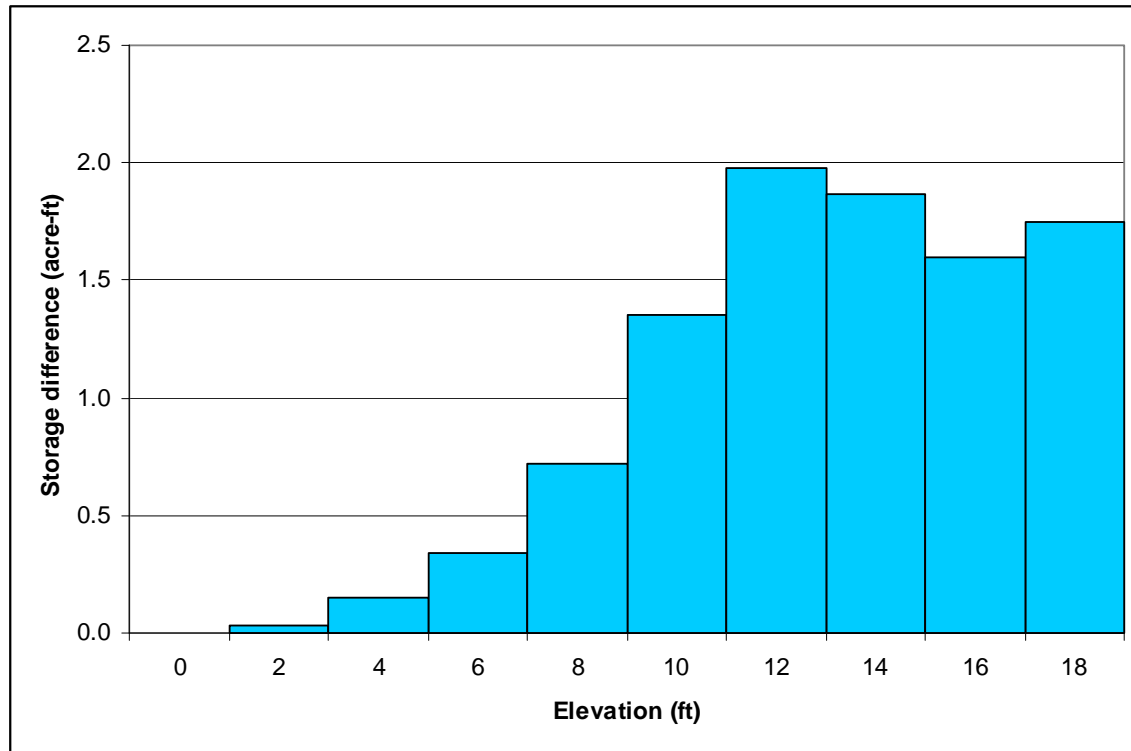
The following graph shows the difference in storage volume at various stages. Note that the increase in storage decreases beyond 12 feet elevation. Therefore, the elevation of the dam should be less than 12 feet.

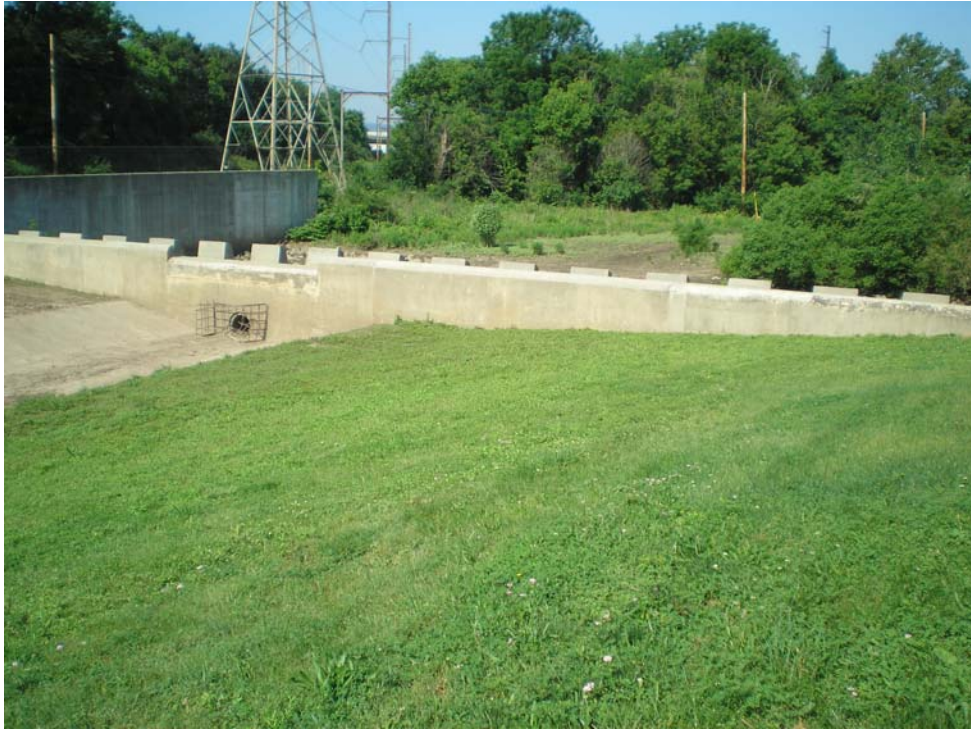
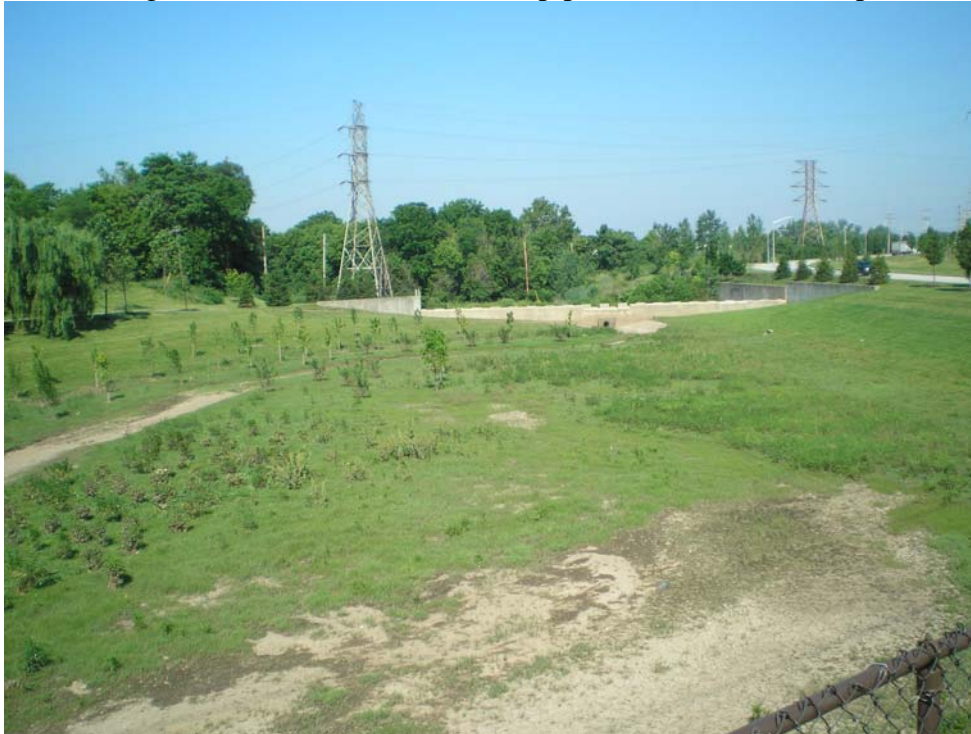
View facing downstream, note base-flow pipe at center of dam's upstream face

View of the detention area upstream from the dam. This structure is only a few years old and the trees and shrubs planted in the detention area are still quite young. The detention area has been observed to be completely full on occasion and there have been no deleterious effects on the

vegetation from being inundated for a couple of days while the detention area drains. So, in time the detention area will be reforested.

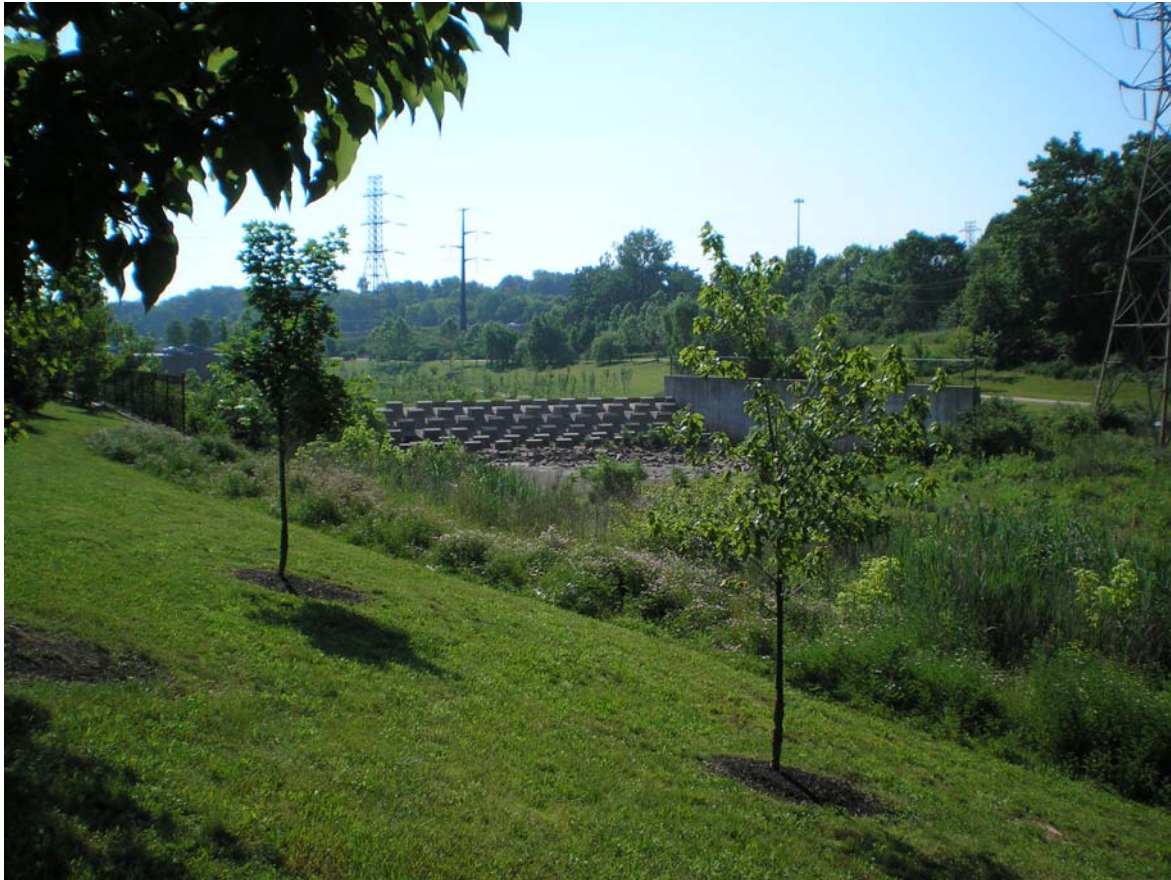
View of the downstream dam face. There is a small area downstream from the dam where sediment accumulates and then about 100 feet downstream from the dam, the stream channel reforms and is a natural channel.

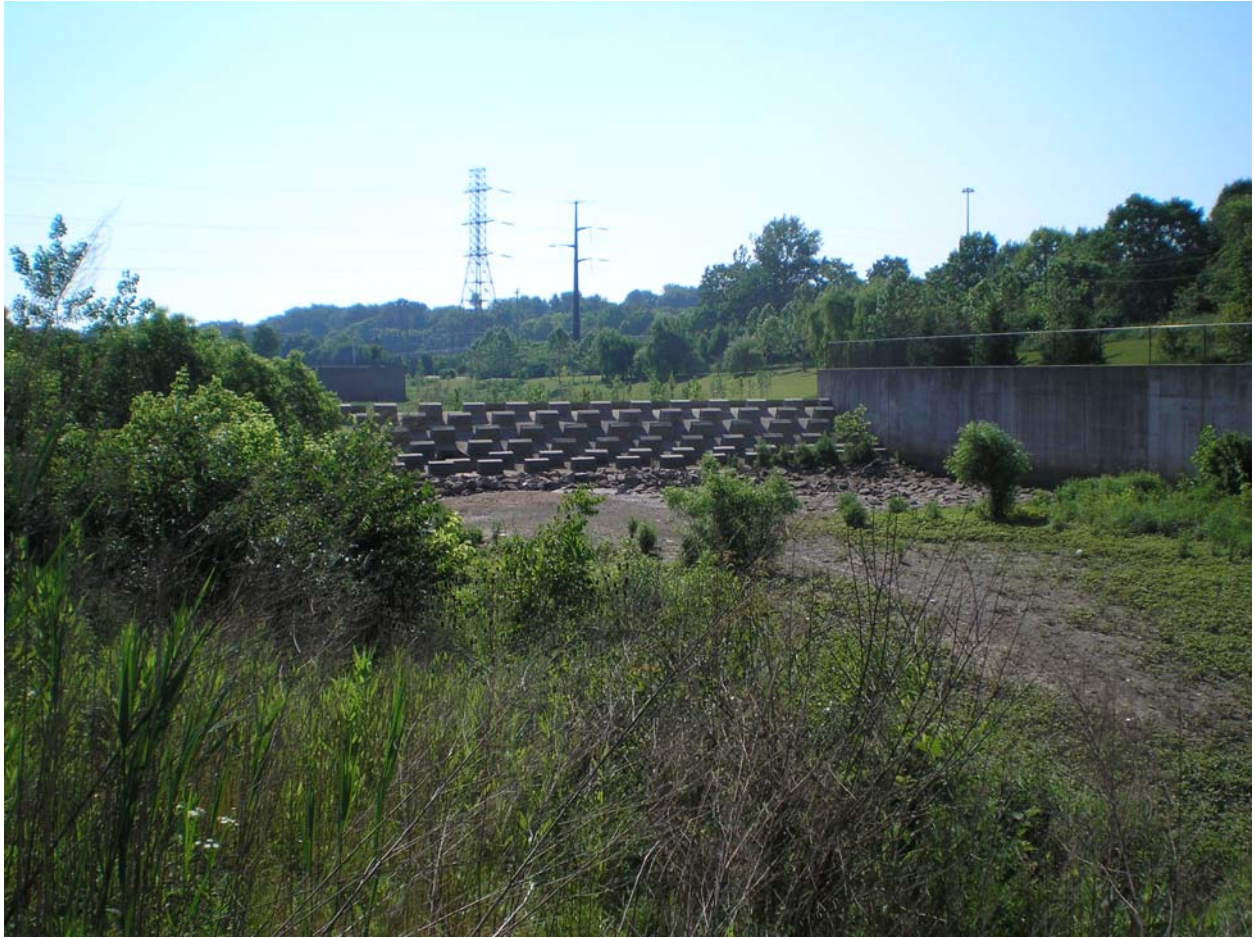
View of the downstream dam face. There is a small area downstream from the dam where sediment accumulates and then about 100 feet downstream from the dam, the stream channel reforms and is a natural channel.
