Sandy Run Creek Watershed Field Observations and Stormwater Management Improvements

Field Observations

Opportunities for Stormwater Management Improvements

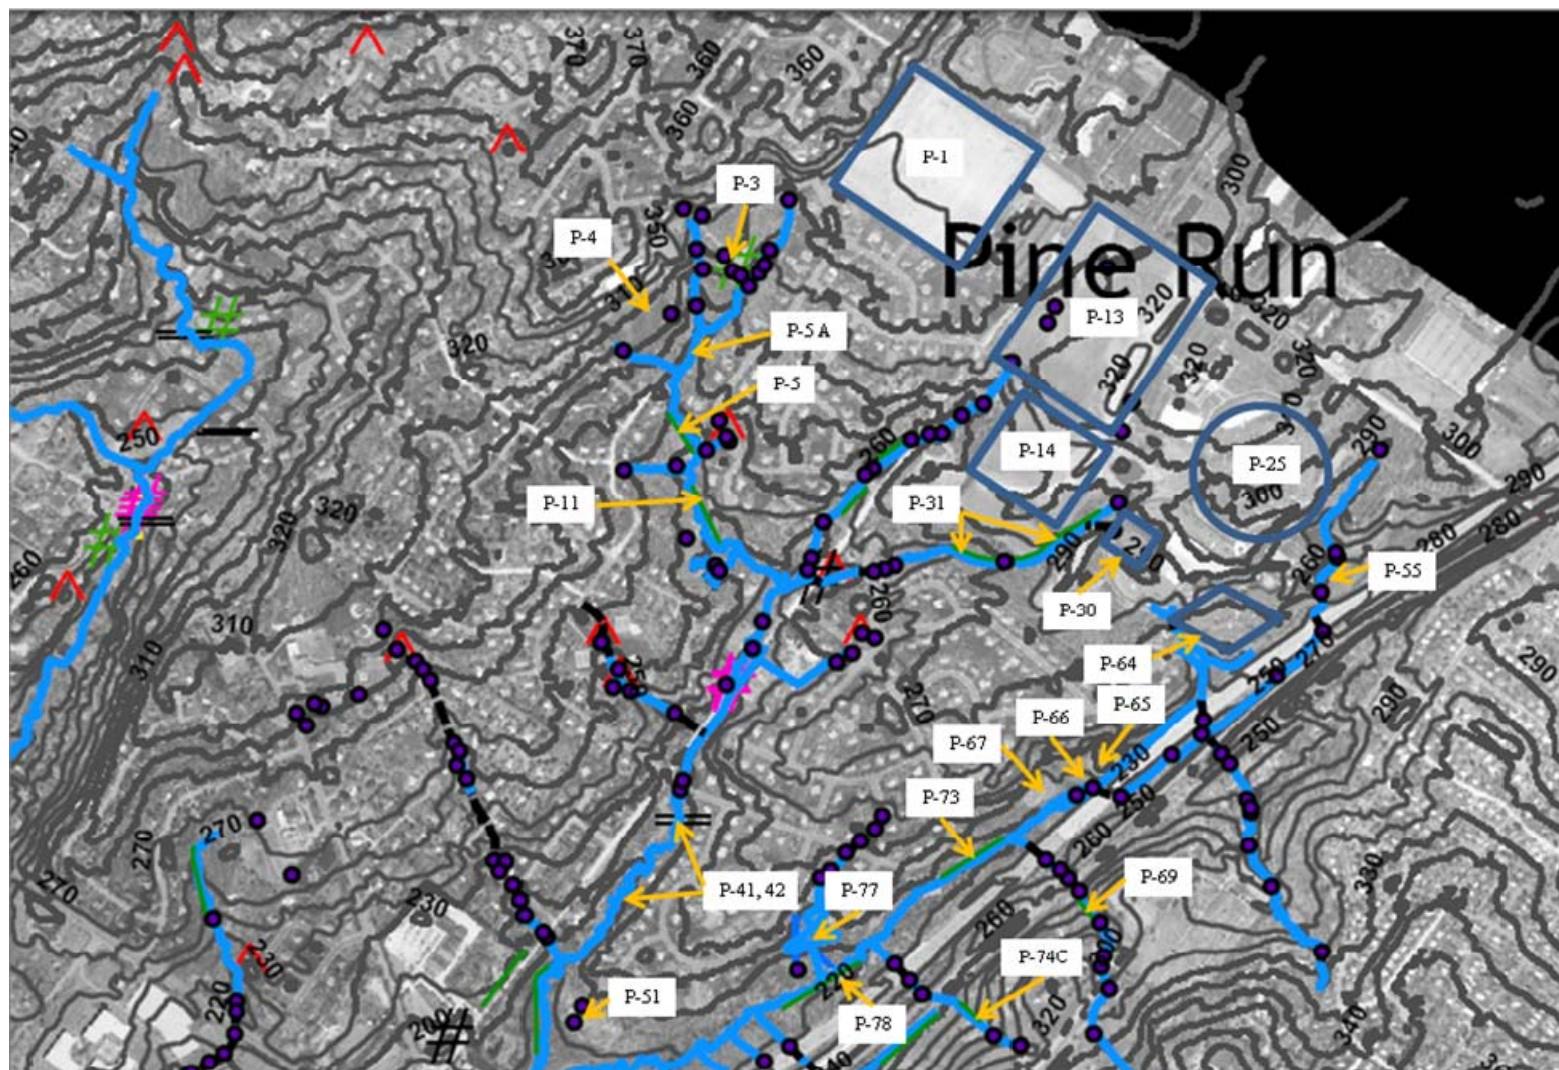
Figure 1: Pine Run – Upper Portion of Watershed - Showing Potential Improvement Sites

Storage discharge relation for dam P-73 (Refer to Figure 1 for general location).

Storage discharge relation for dam P-78 (Refer to Figure 1 for general location)

Storage discharge relation for dam P-82 (Refer to Figure 1 for general location)

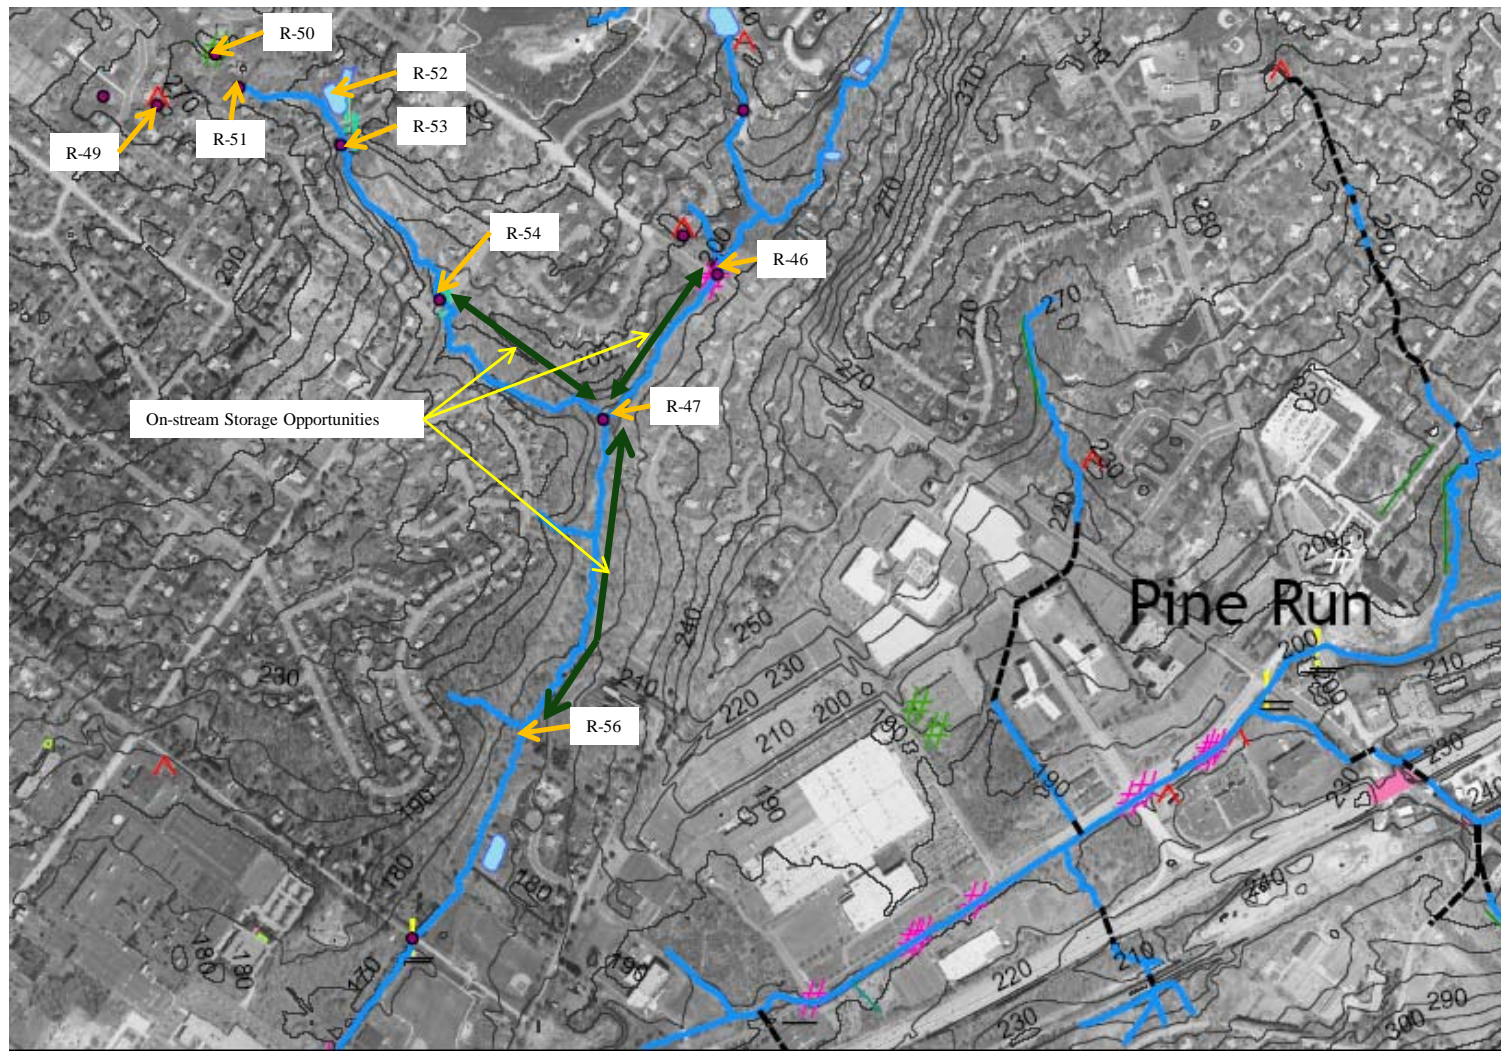
**Figure 4: Rapp Run – Lower Portion of Watershed
Showing Potential Improvement Sites**

Storage discharge relation for dam R46 (In reach between R46 and R47 on Figure 4)

Storage discharge relation for dam R47 (In reach between R54 and R47 on Figure 4)

Storage discharge relation for dam R56 (In reach between R47 and R56 on Figure 4)

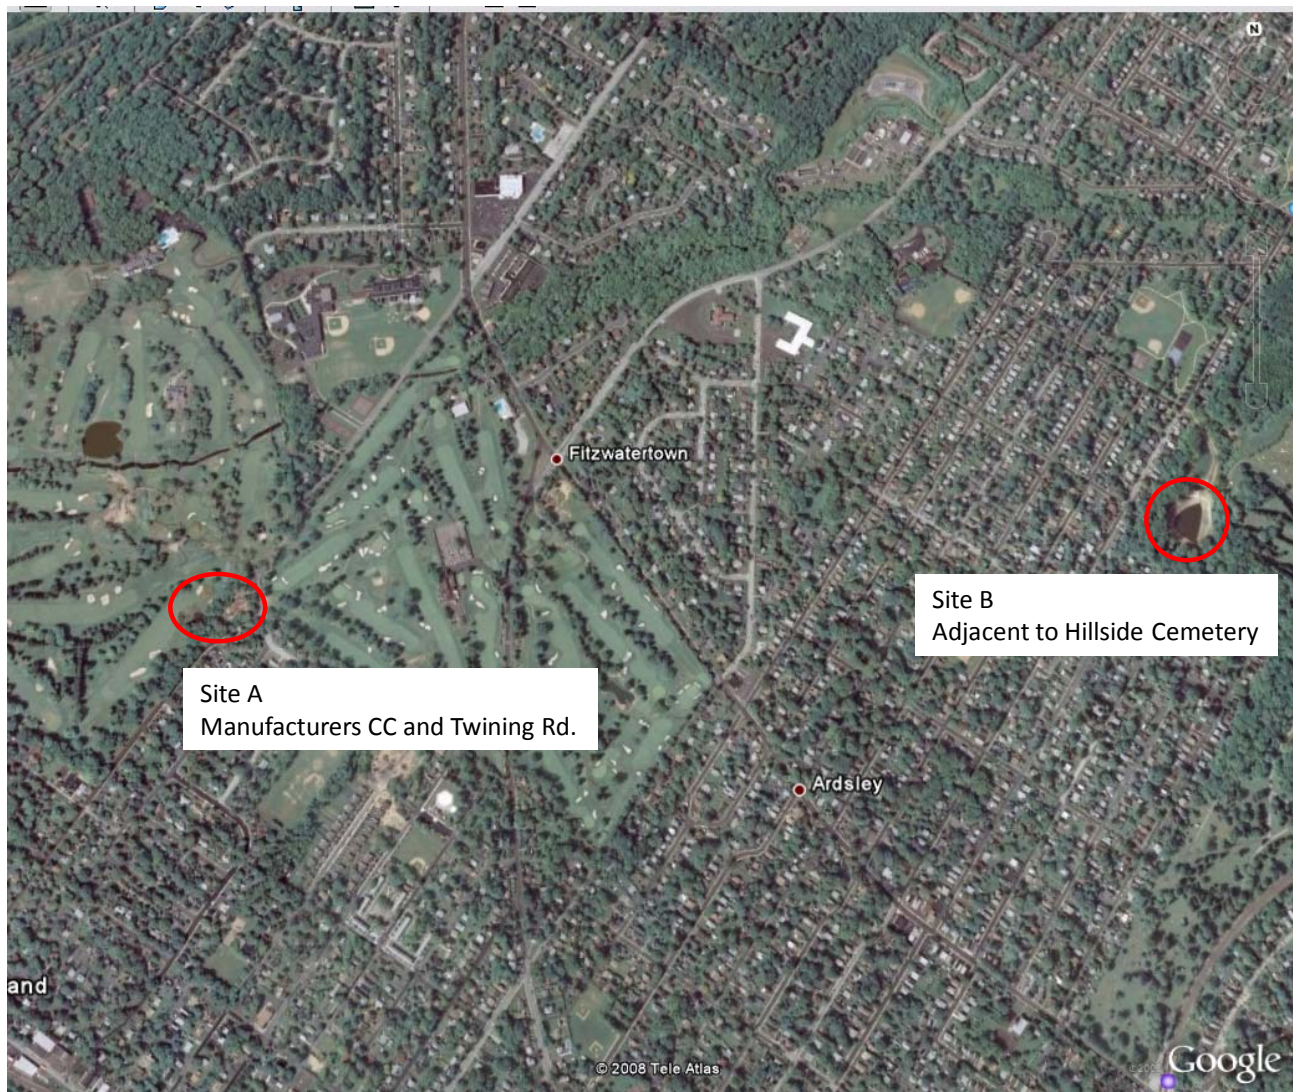
Figure 5: Locations of Potential Improvements in Sandy Run Watershed

Field evaluation of the portion of the Sandy Run watershed south of the Pennsylvania Turnpike identified only two significant opportunities for additional detention, with estimated storage volumes of approximately 30 acre-ft for Site A and 10 acre-ft for Site B, as shown in Figure 5. The HEC-HMS model was used to determine the 2-Year storm flow reduction at the confluence with Pine Run in the Office Park due to these two improvements. The model showed a reduction in peak flow from 4,880 cfs to 4730 cfs, or about 3 percent. This would not provide significant flood stage reduction in the Office Park, although the facilities would provide stormwater control benefits in their respective subbasins within the Sandy Run watershed.

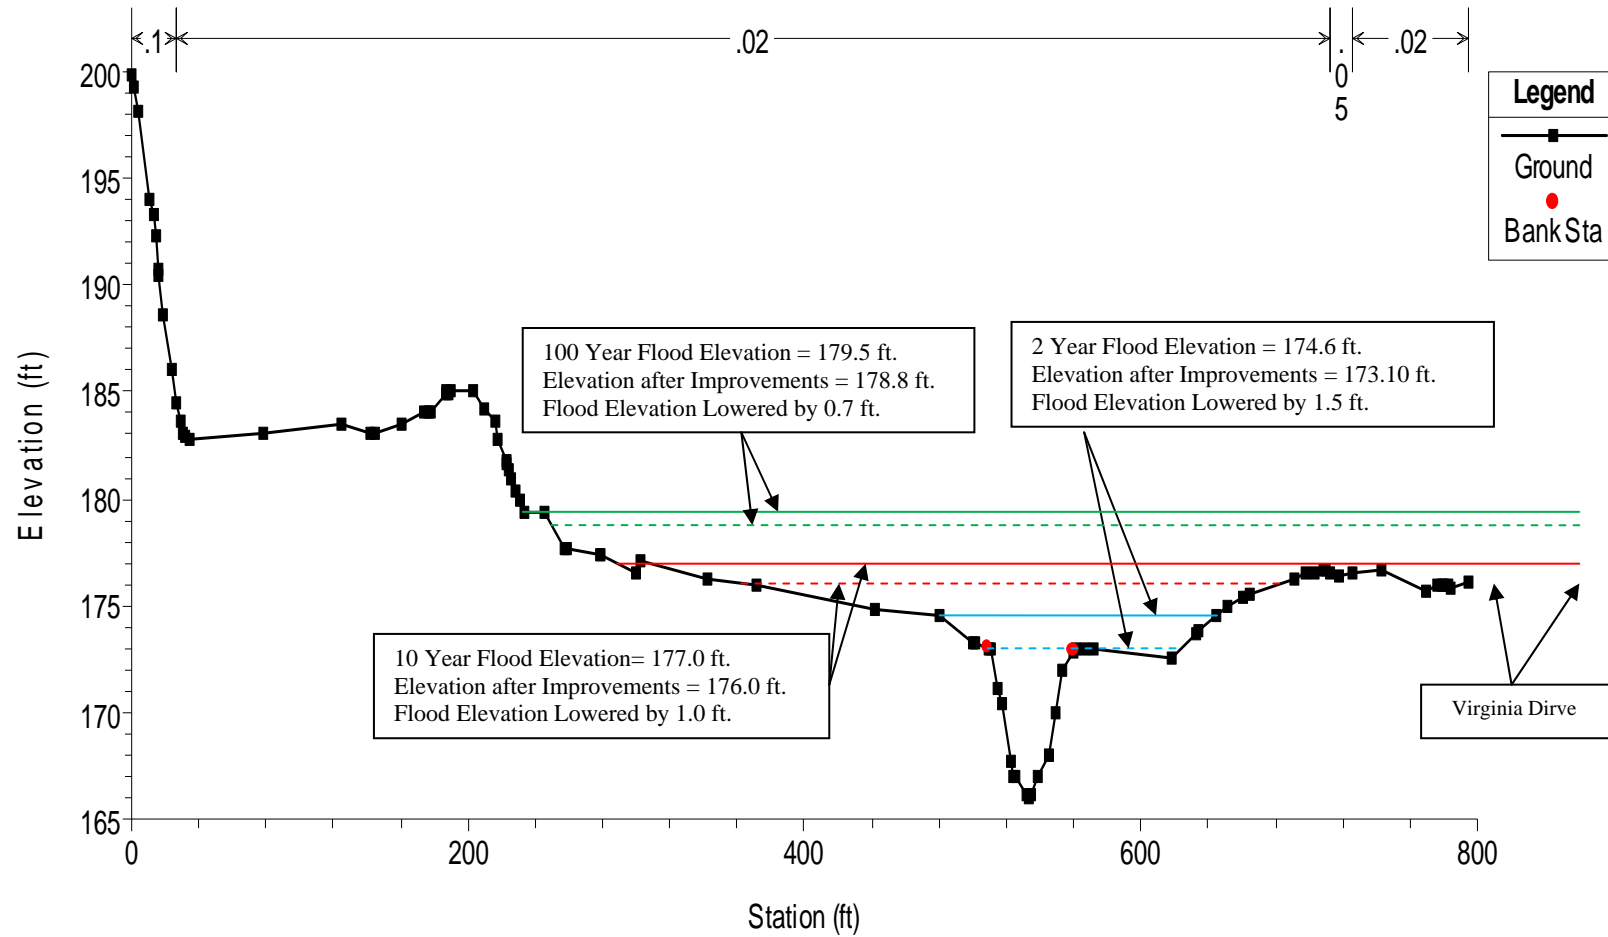
Figure 8: Cross Section 401 Showing 2, 10, and 100 Year Flood Elevations Before and After Improvements
HEC_RAS Reach 152, Station 709.22

Cross section plots for the six highlighted locations showing the pre and post improvement flood elevations for the 2-Year, 10-Year, and 100-Year storms are provided in Figures 8 thru 13. The plots are oriented looking downstream, with the PA Turnpike to the left of the plot. The approximate location of Virginia Drive is also shown. The plots illustrate the relative magnitude of change in flood elevations for the 10-Year vs. the 2-Year storm when the potential improvements are considered. The results clearly indicate that despite significant reductions in elevations for 2-Year storm, the potential stormwater improvements evaluated do not provide enough volume to eliminate severe flooding in the Virginia Drive area during larger storm events.
